# Stains – Identification and Prevention

**Abstract:** This *Technical Note* provides descriptions and photographs that aid in identifying commonly found stains and efflorescence on brick surfaces. This document includes information on stain composition, factors that influence their occurrence and methods of prevention.

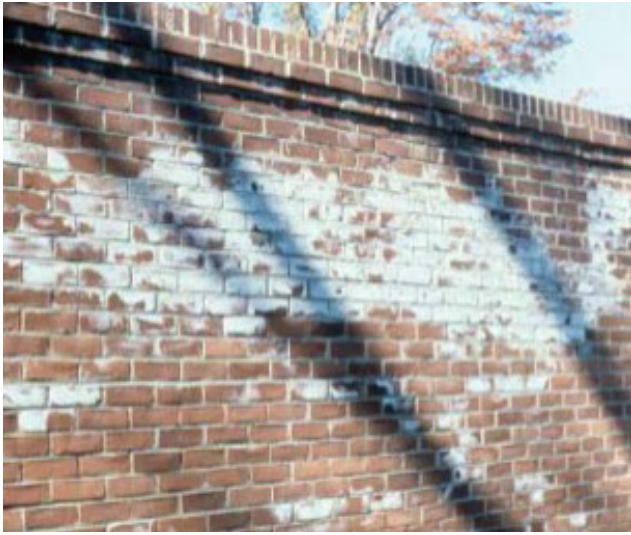
**Photo 1**  
**Efflorescence**

Efflorescence is not considered a stain but will be discussed here for identification purposes. Refer to *Technical Note 23A* for causes and prevention. Efflorescence is usually a white, crystalline deposit on the brick surface. However, not all white stains on brick masonry are necessarily efflorescence. For instance, lime run and white scum are other types of white stains that are occasionally mistaken for efflorescence. Efflorescence is normally harmless and occurs when water-soluble salts are taken into solution within the masonry, carried to the surface through evaporation and deposited on the brick surface after the water evaporates. This results in a powdery, white, crystalline deposit as shown in [Photo 1](#). Efflorescence may occur in a variety of locations on brickwork. In some instances, efflorescence may appear only on the mortar joints, as shown in [Photo 2](#). In other instances,

efflorescence may appear in limited areas on the surface of brickwork as shown in [Photo 3](#) or, in extreme cases, cover the entire brick surface, as shown in [Photo 1](#).

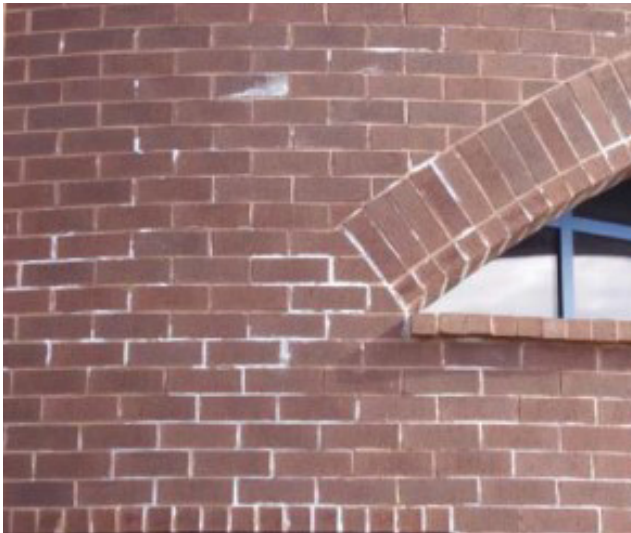
**Photo 2**  
**Efflorescence on Mortar Joints**

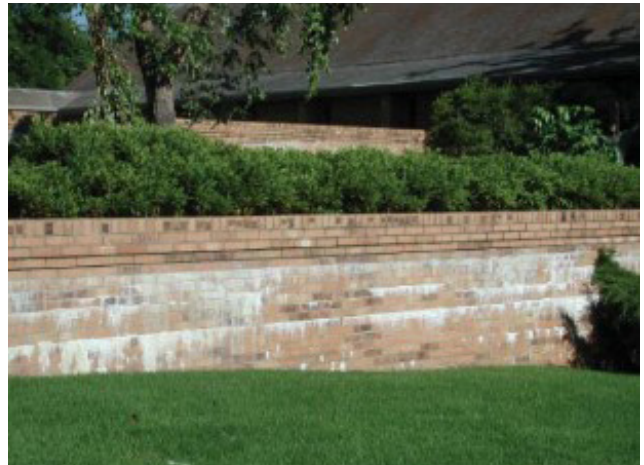
**Photo 4**  
**Lime Run**

Calcium carbonate deposits, sometimes referred to as “lime run,” usually appear as white or gray crusty formations. This is also not technically a stain but is rather a deposit. These deposits can be found emanating from weep holes or from fine cracks between brick and mortar joints. The term “lime run” refers to the pattern formed by the salt as it travels down the face of the wall, as shown in [Photo 4](#) and [Photo 5](#). Due to their white appearance, lime run stains are sometimes mistaken for efflorescence. However, after lime run fully carbonates it is water insoluble, whereas efflorescence is water soluble. The term “lime run” can be misleading since the stain is not a direct result of the lime component in the mortar. In fact, hydrated lime can actually help reduce the risk of lime run. The source of the calcium compounds

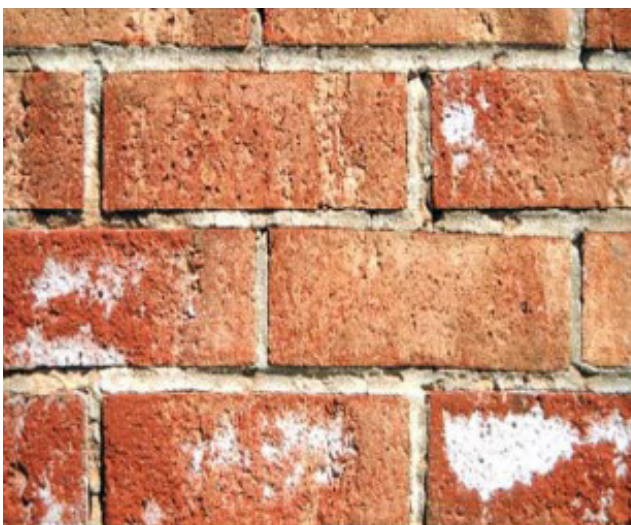
**Photo 3**  
**Efflorescence in Limited Areas**

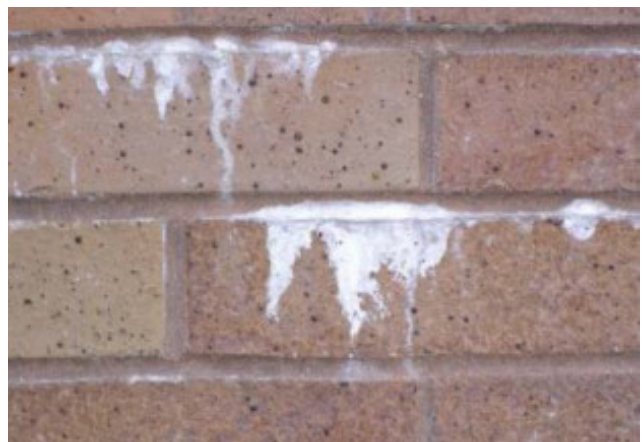
**Photo 5**  
**Lime Run**

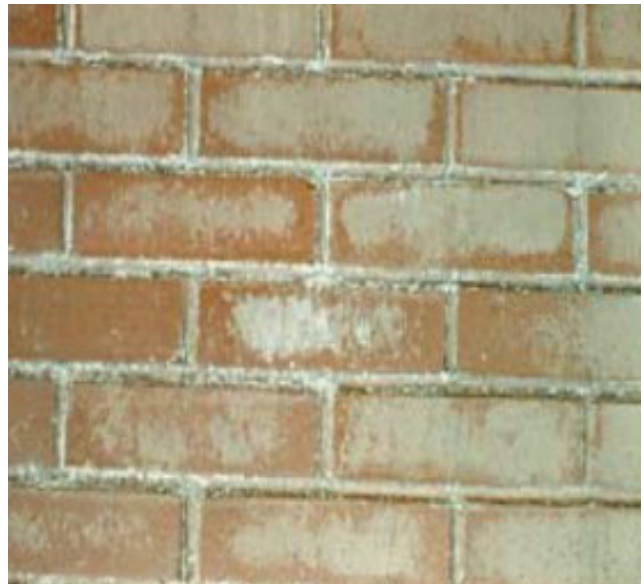
**Photo 6**  
**White Scum**

Silicate deposits, often referred to as white scum, usually appear as white or gray discolorations on the face of brick masonry, as shown in [Photo 6](#). The discoloration may be present over the entire face of the brickwork or in smaller, irregularly shaped areas. White scum may also occur adjacent to masonry trim elements, precast concrete and, occasionally, large expanses of glass.

White scum is typically related to the cleaning of brickwork with unbuffered hydrofluoric or hydrochloric (muriatic) acid, or other improper acidic cleaners. It can also occur when an insufficient amount of water is used while prewetting or rinsing during cleaning activities with some acidic solutions. In either scenario, components of the brick and mortar dissolve in the acidic cleaner and produce insoluble silicate deposits on the wall surface. White scum is not water soluble like efflorescence and cannot be removed as easily. Specialty cleaning solutions, recommended by the manufacturer, should be used to remove silicate deposits from the wall surface.

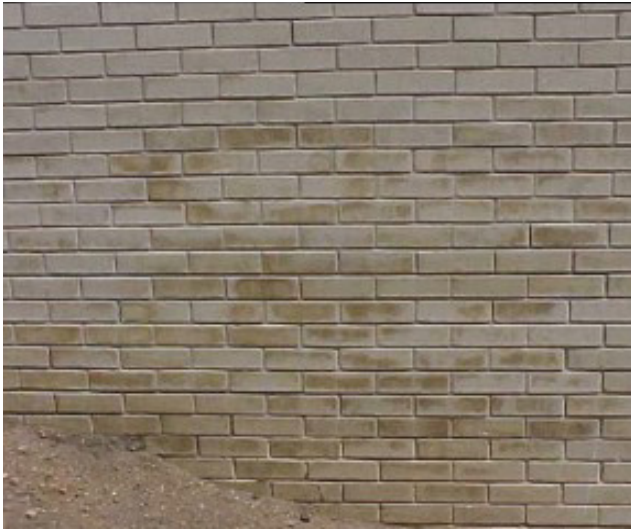
**Photo 7**  
**Yellow Vanadium Stain**

Vanadium stains are yellow, green or purple salt deposits in the heart of light-colored brick units, as shown in [Photo 7](#) and [Photo 8](#). Vanadium stains occur when vanadium salts present in clays used to manufacture light-colored bricks come in contact with an acidic environment, such as unbuffered hydrofluoric or hydrochloric (muriatic) acid cleaners or acid rain. They may be found on tan, buff or white brick; however, they are more conspicuous on lighter-colored brick. The yellow, green and purple stains are usually crystallized vanadium salts, consisting of sulfates and chlorides, or hydrates of these salts.

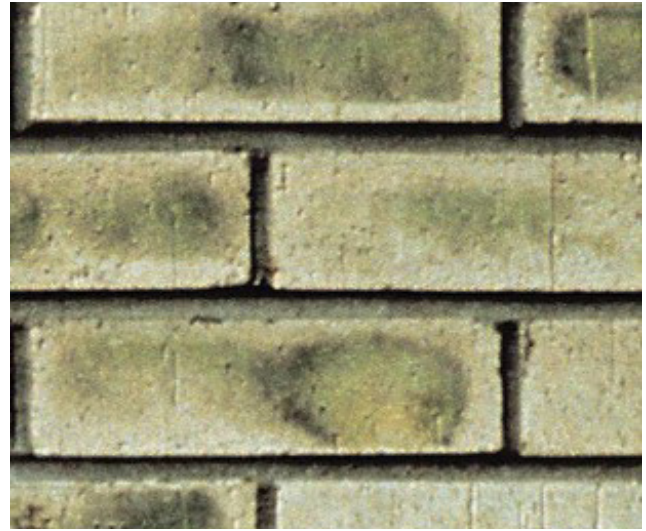
**Photo 8**  
**Green Vanadium Stain**

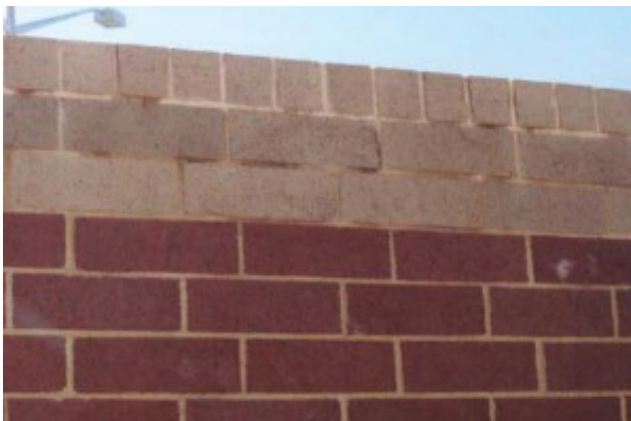
**Photo 9**  
**Manganese Stain**

Under certain conditions, tan, brown or occasionally gray staining may occur on the mortar joints of brickwork, as shown in **Photo 9**. Occasionally, a brown stain will extend onto the faces of the brick, as shown in **Photo 10**. This type of stain is the result of using manganese oxide as a coloring agent in tan, brown, black or gray brick and its reaction to an acid.

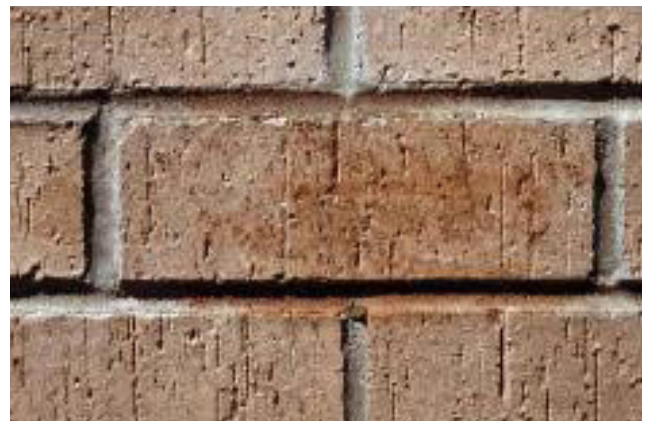
**Photo 10**  
**Manganese Stain**

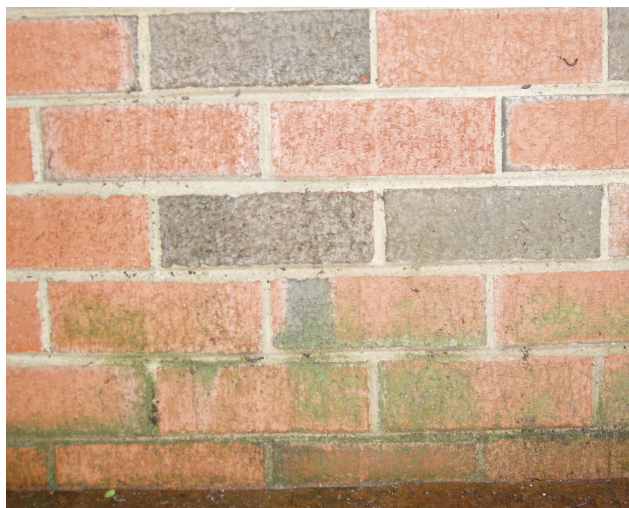
**Photo 11**  
Organic Stain

**Biological Growth.** Masonry that remains in a damp condition or is in a minimally sunlit location can lead to organic/biological growth on its surface. Stains that are isolated to the north facade or north-facing elements of the facade are likely related to biological growth. These stains will also be concentrated along areas that are frequently wetted, such as parapet caps, or under projecting elements, such as window sills. Biological growth/ organic stains, as shown in [Photo 11](#), can include algae, lichen, mildew or other organisms.

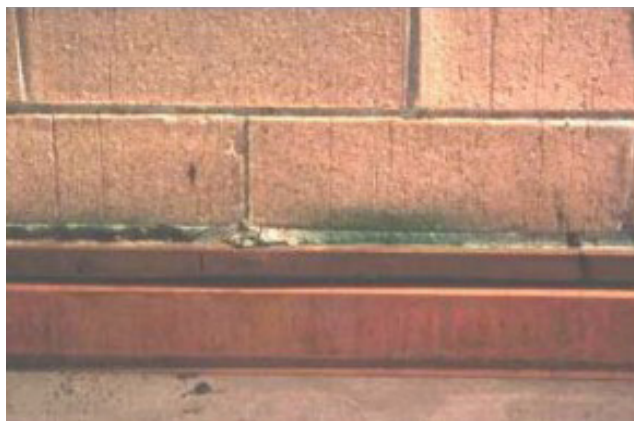
**Photo 12**  
Stain from Copper

**Adjacent Materials.** Certain materials above or adjacent to brickwork such as copper ([Photo 12](#)), bronze, aluminum, synthetic stucco or paint ([Photo 13](#)) can stain brickwork surfaces. In addition, externally caused stains such as hard water from sprinkler systems can affect brickwork ([Photo 14](#)).

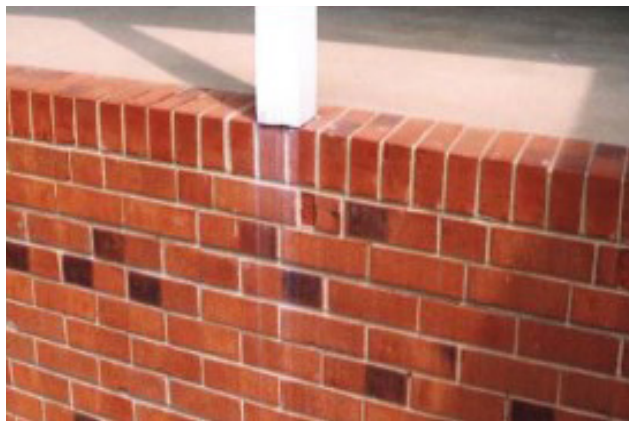
**Photo 13**  
Runoff Stain from Paint

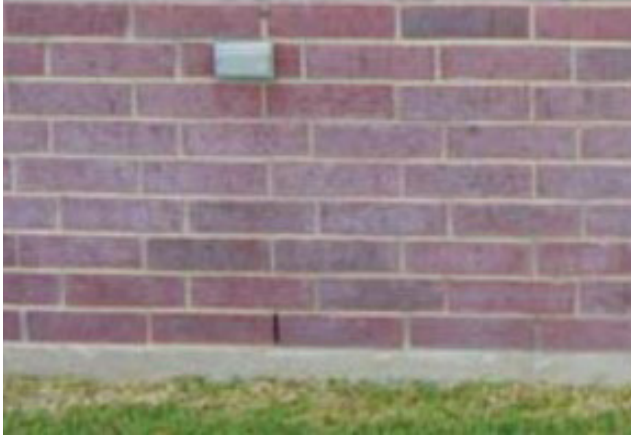
**Photo 14**  
**Hard Water Stain**

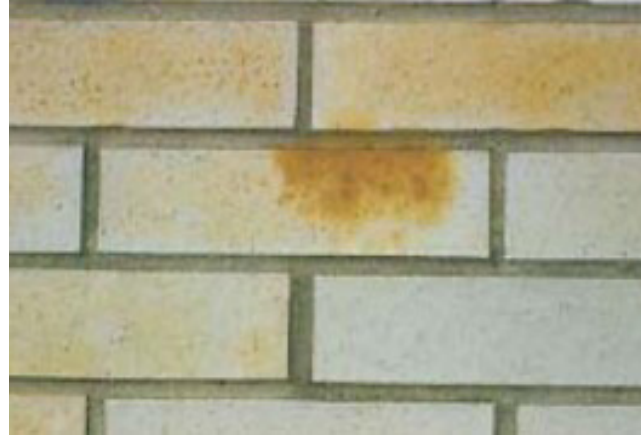
**Photo 15**  
**Rust Stain**

**Rust.** Rust-colored stains may actually be corrosion, as shown in [Photo 15](#). Such stains can be the result of corrosion of wall ties or joint reinforcement in or adjacent to the brickwork. The use of improper mortar additives or ingredients, placement of wall ties or joint reinforcement with inadequate cover, welding splatter on the brick, or the corrosion of a material placed on the brick cube or pile prior to being laid in the brickwork can all contribute to these stains.
